ECED June 2019

Demolition of iconic (ikonicky) structures at Sellafield

Bruce Wilson

Head of Projects
Beta Gamma Remediation

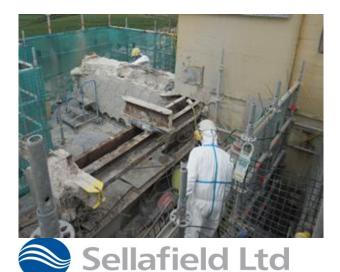
- Built over 60 years ago to standards below current requirements
- •Increased contamination from 1957 fire
- •Large quantity of concrete to remove from circa 120 metres
- •Close to ageing legacy buildings

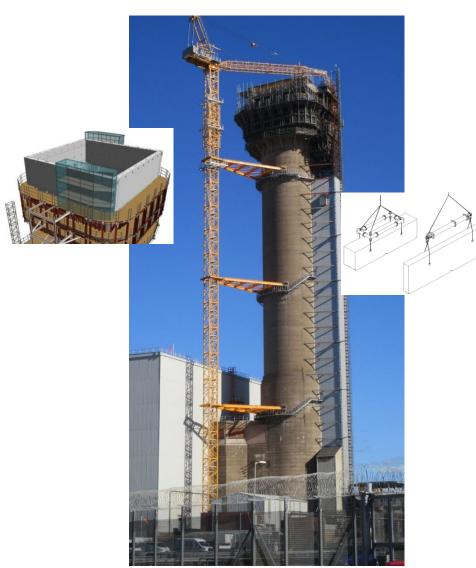
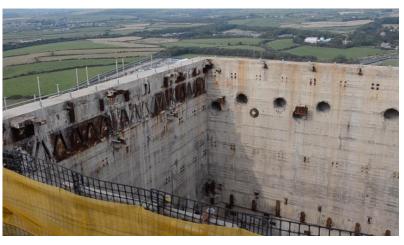
Pile 1 Chimney Demolition

- Pile 1 Chimney Filter Gallery demolition completed.
- Over 700te of concrete, brick and steel disposed of
- •158m tall tower crane installed to lower concrete blocks to ground
- 3500 tonnes of structural steel and concrete to be demolished.
- •Removal of structure in block form using diamond wire cutting
- Project timeline Dec 2016 to June 2028

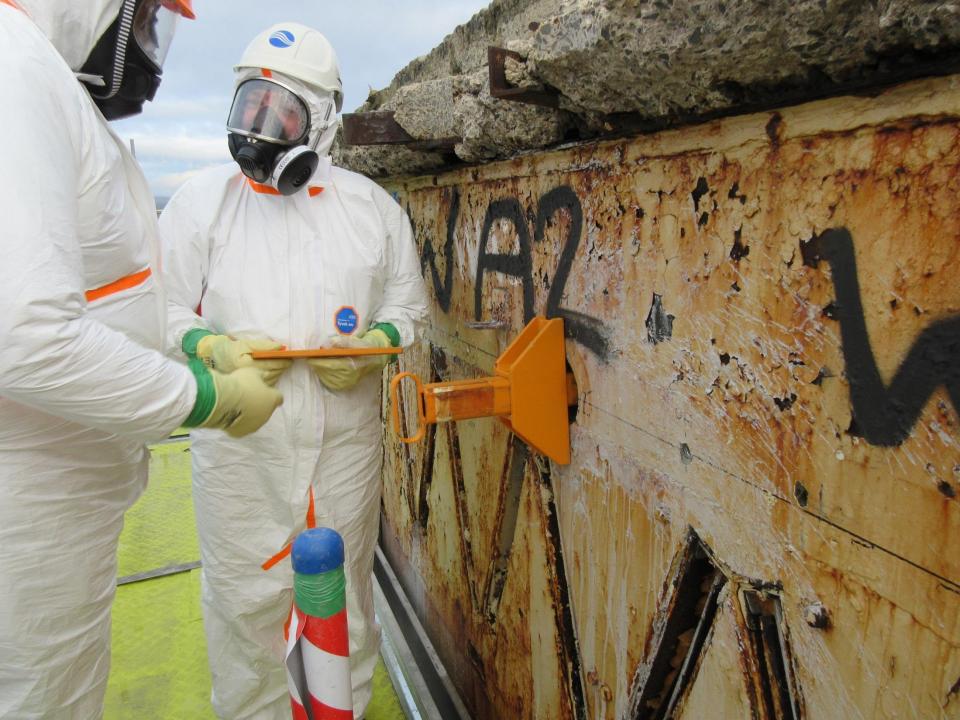
Blocks 46 & 47 ready for final cut

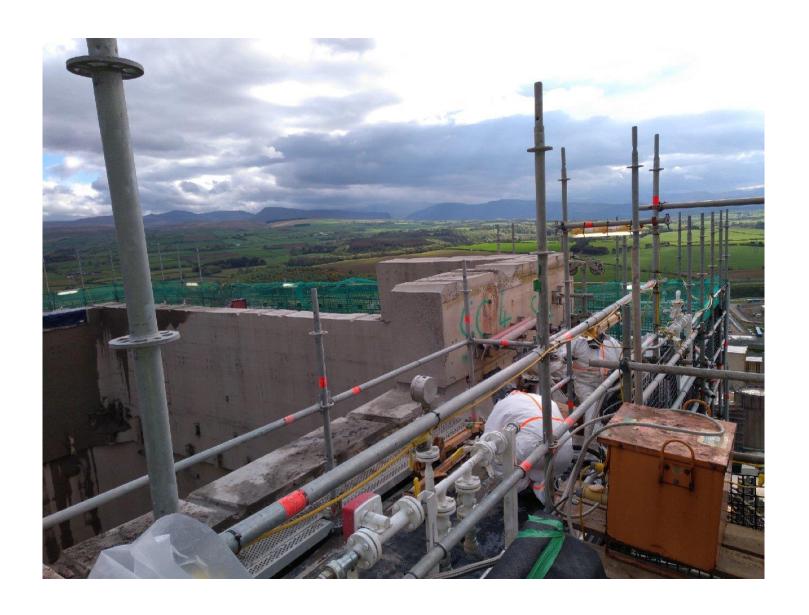
Rows A-C removed c. 330te concrete & 3m height

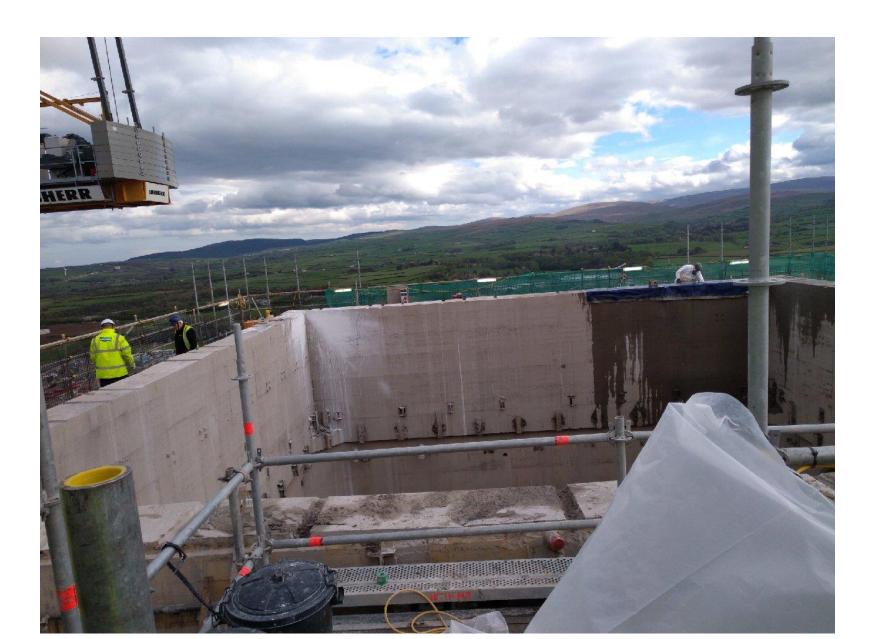
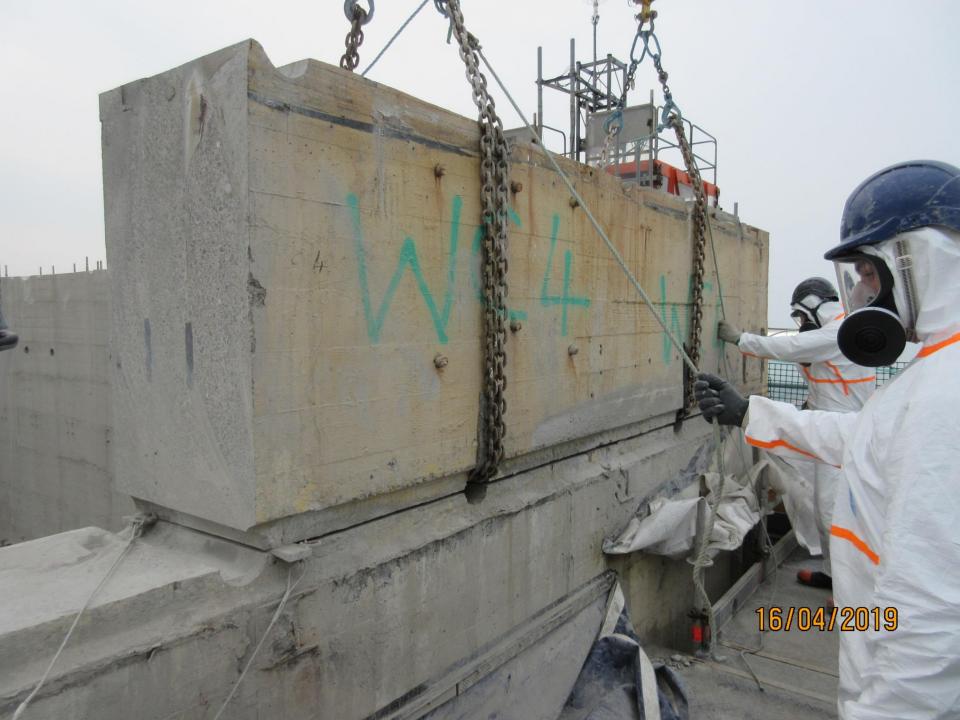
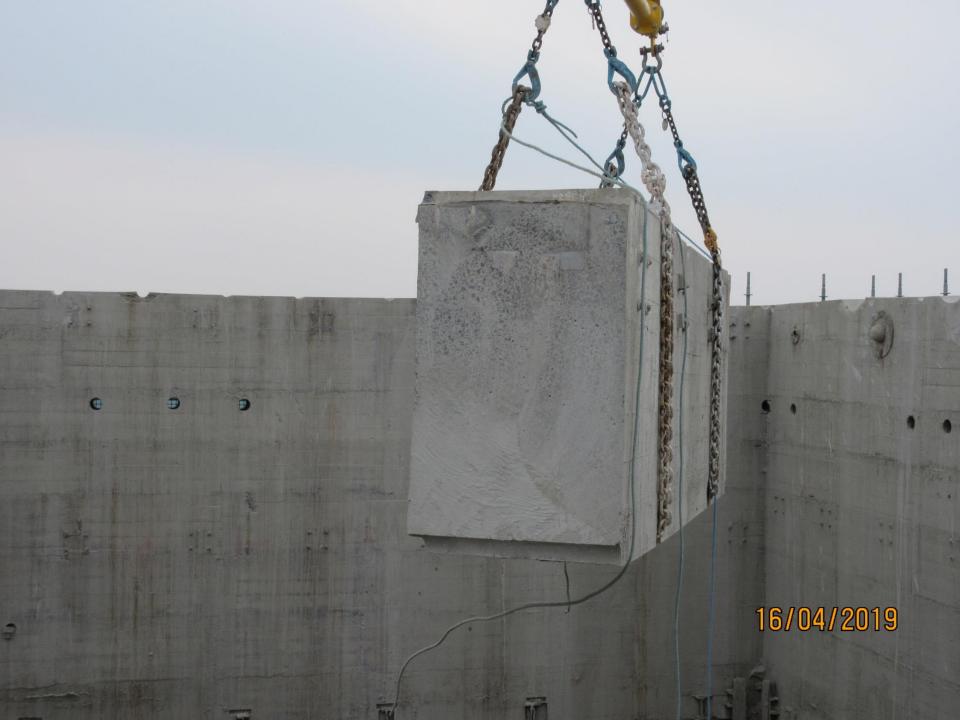
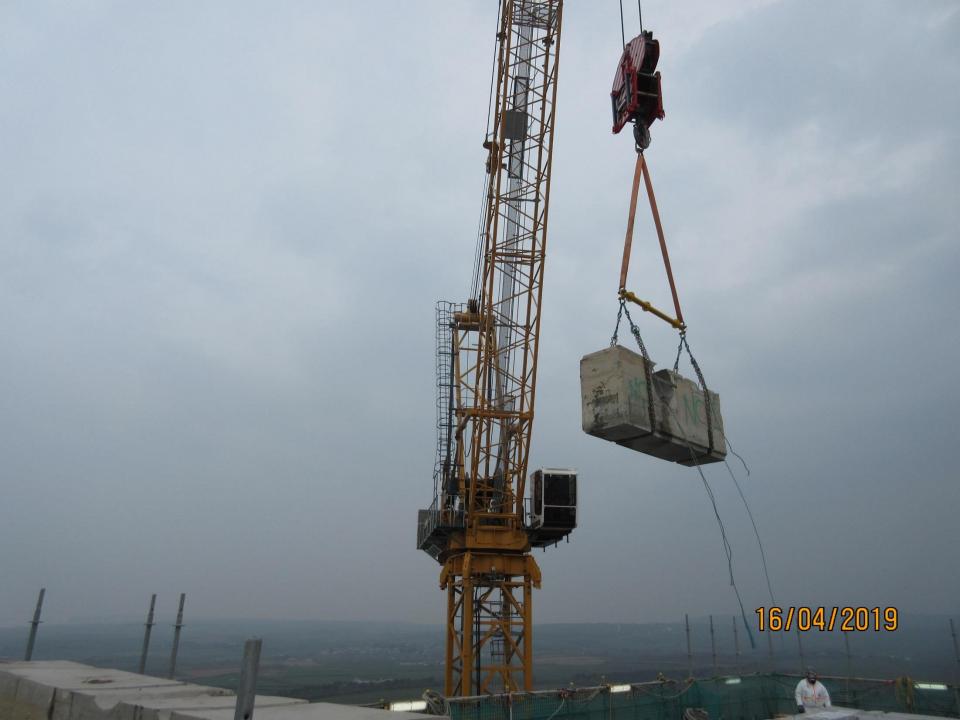
Barrel demolition concept

- Driver is skyline change and care & maintenance cost, not risk reduction
- Use crane to construct platform
- Detailed Design ongoing
- Planned direct award to incumbent DDP partner

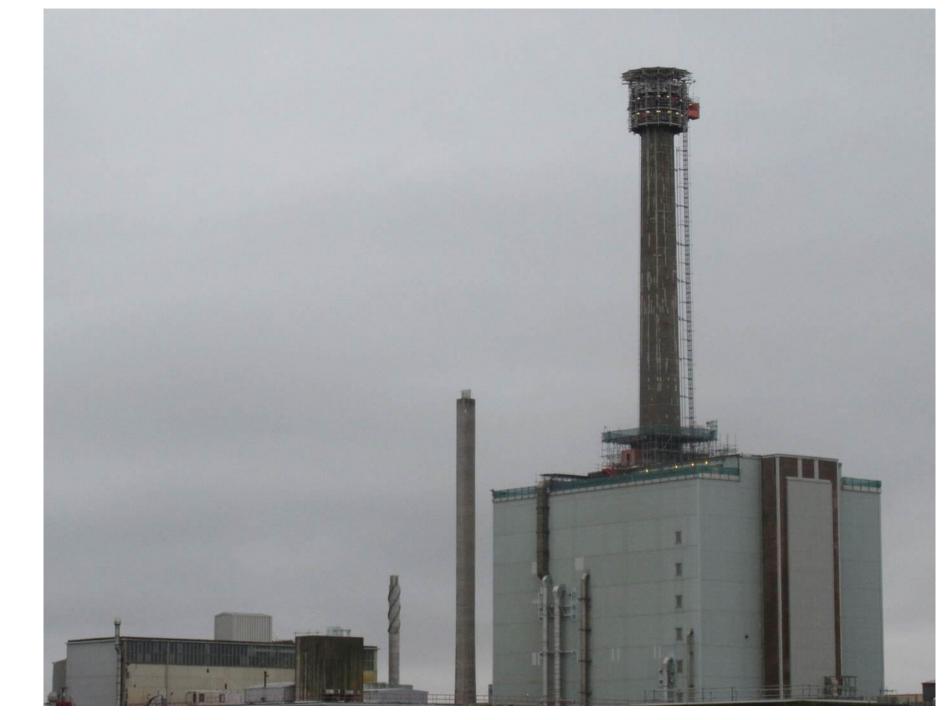
- First Generation Reprocessing Plant (FGRP) Stack was constructed and commissioned in the early 1950's
- The FGRP Stack was an authorised gaseous aerial discharge outlet for a number of operational and decommissioning buildings
- Standing 120m above ground the stack consisted of a reinforced concrete wind shield with stainless steel flue liner.
- The stack structure did not meet modern structural standards.
- Consequence of a stack collapse was potential damage to a number of Nuclear Facilities.
- Key enablers for the demolition of the stack was the completion of the SAV project

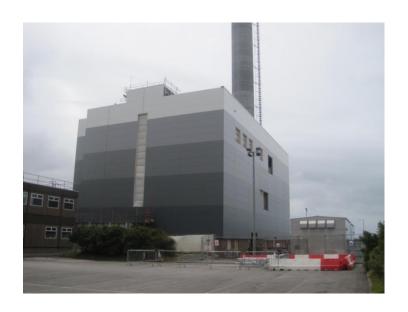
Stack Demolition - 2 Part Solution Part 1 - SAV

- Part 1 The key enabler for Stack
 Demolition is the transfer of operations to a new ventilation discharge stack facility and associated systems
- The SAV Facility took over ventilation operations in Aug 2016

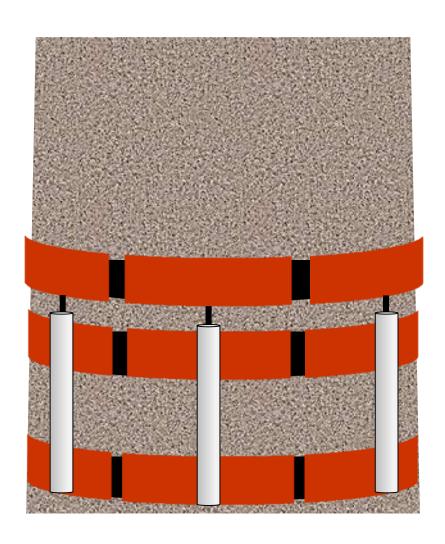
SCP Climbing methodology

Lifting Band

Upper Restraining Band URB

Lower Restraining Band LRB

Lifting band Tooktened ready for steak rise

URB tightened

Lifting band lifted to U&LRB lifted required height with the SCP QRB ordintened

URB loosened

LRB loosened

• The SCP is supported by 3 friction bands (2off restraining bands 1off lifting band) which holds it in position on the stack.

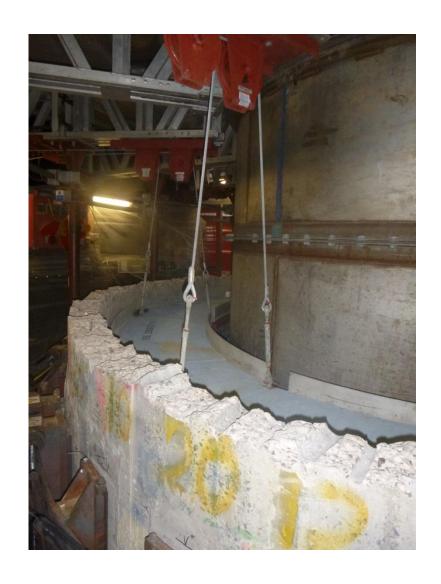
- SCP ascent completed December 17
- Demolition in progress
- 7 day cycle
 - Drilling 2 days
 - Bursting
 - Decontam
 - Plasma cutting
 - Prep day
 - Move day
- Category A Hazard Retirement Point (47m) June 2018 - COMPLETED
- Demolition Forecast Complete Nov 2019
- Project Closure Forecast Complete Apr 2020

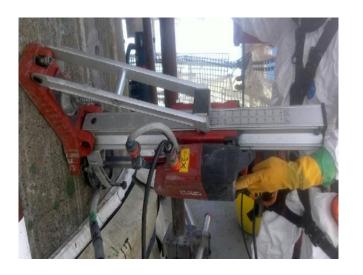
Demolition

- Approximately 640 tonnes of Very Low Level, Non Hazardous waste concrete will be removed from the stack and disposed off within the Sellafield boundary (CLESA)
- Approximately 25 tonnes of stainless steel waste will be removed from the flue. Radiological monitoring will be carried out when steel becomes accessible and waste disposed appropriately
